# Manhole Inspection Summary

Manhole # S13EE\_029MH

Insp Date: **9/18/07 3:55 PM**

**Location** Address: **1416 DUKELAND ST**

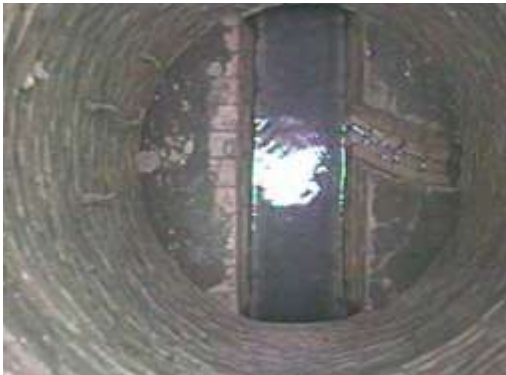
Top View

DEBRIS ON BENCH

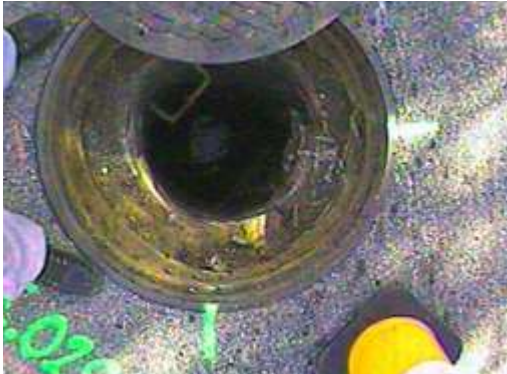
Top View

Offset: **6** (in.)

FRAME OFFSET

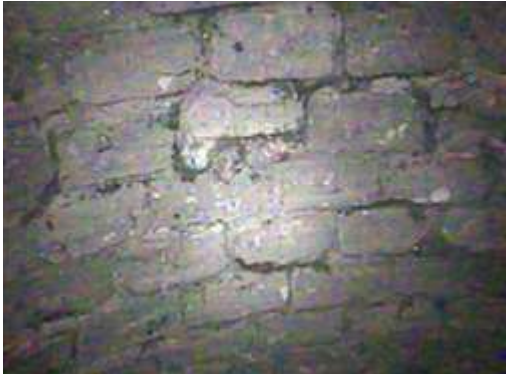
Defect 1

Count: **6** Missing: **5** ☒ **Corroded**

MISSING/CORRODED RUNGS

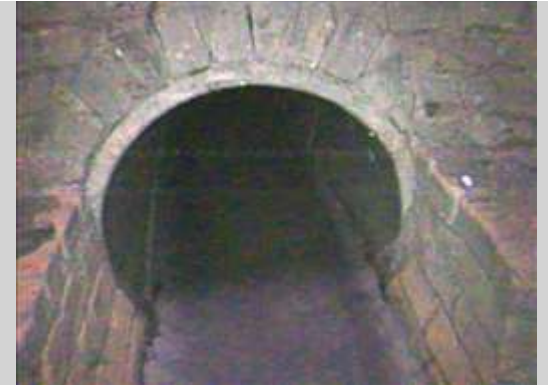
12 O'Clock Outflow

18 in. Circular Gravity Sewer  
Pipe Out @ 12 O'Clock

Pipe Height: **18** (in.) Rod and Bar (Angled)  
Pipe Material: **Clay** ☐ Pipe Lined  
Invert Depth: **11.48** (ft.) Flow Characteristics: **Slow**  
Deposits: ☒ None ☐ Mud ☐ Sludge ☐ Debris ☐ Grease  
Silt Depth: (in.) Deposits Extent:  
Infiltration: **None** Pipe Seal Cond: **Sound**

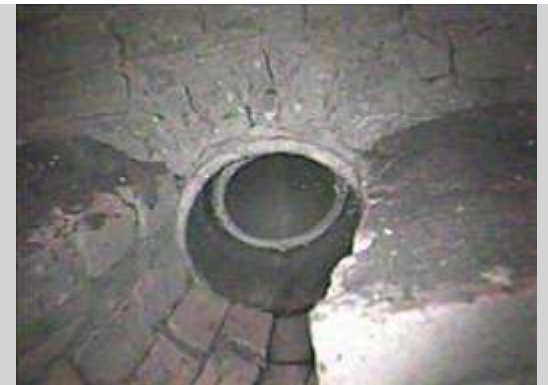
3 O'Clock Inflow

8 in. Circular Gravity Sewer  
Pipe In @ 3 O'Clock

Pipe Height: **8.4** (in.) Rod and Bar (Angled)  
Pipe Material: **Clay** ☐ Pipe Lined  
Invert Depth: **10.91** (ft.) Flow Characteristics: **Slow**  
Deposits: ☒ None ☐ Mud ☐ Sludge ☐ Debris ☐ Grease  
Silt Depth: (in.) Deposits Extent:  
Infiltration: **None** Pipe Seal Cond: **Sound**

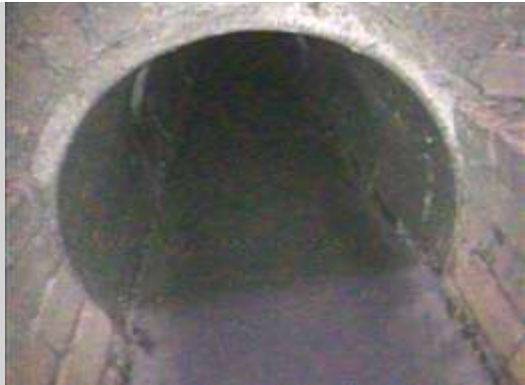
6 O'Clock Inflow

18 in. Circular Gravity Sewer  
Pipe In @ 6 O'Clock

Infiltration: **None** Pipe Seal Cond: **Sound**
